NATIONAL PHOTOGRAPHIC INTERPRETATION CENTER

RUNWAY REPAIR VINH AIRFIELD, NORTH VIETNAM 18-44N 105-40E

ATTACHMENT TO M-6925
20 JUNE 1969
PAGE 1 OF 2

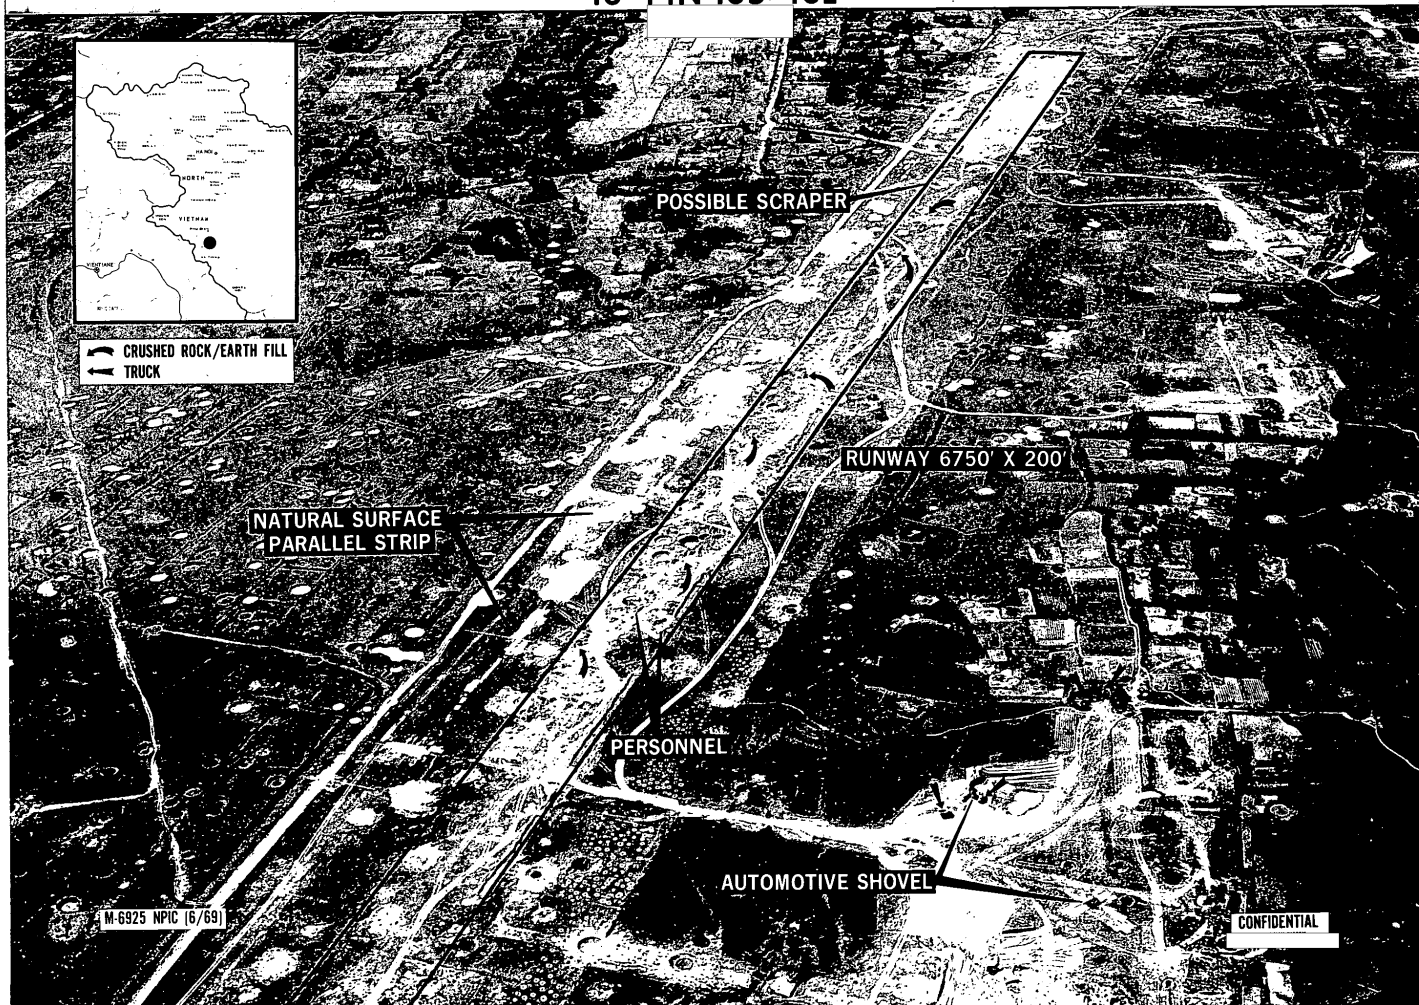
THIS BRIEFING BOARD DEPICTS INITIAL ATTEMPTS BY THE NORTH VIETNAMESE TO REPAIR THE RUNWAY AT VINH AIRFIELD.

INITIAL STAGES OF REPAIR TO THE 6750 x 200 FT, NORTH-SOUTH RUNWAY AT VINH AIRFIELD. REPAIR ACTIVITY PRIMARILY CONSISTS OF PERSONNEL BEING UTILIZED TO FILL CRATERS WITH CRUSHED ROCK AND EARTH. AT LEAST 15 CRATERS ARE BEING FILLED AND APPROXIMATELY 20 CRATERS HAVE CRUSHED ROCK/EARTH FILL PILED NEAR OR AROUND THEM. FOUR TRUCKS AND TWO AUTOMOTIVE SHOVELS ARE LOCATED ADJACENT TO THE EAST SIDE OF THE RUNWAY AND A POSSIBLE EARTH SCRAPER IS LOCATED TOWARD THE NORTH END OF THE RUNWAY. THE NATURAL SURFACE PARALLEL STRIP IS SERVICEABLE. NO AIRCRAFT ARE OBSERVED. SEVERAL OCCUPIED ANTI-AIRCRAFT ARTILLERY SITES ARE OBSERVED IN THE AREA OF THE AIRFIELD (NOT SHOWN ON GRAPHIC).

THE NORTH VIETNAMESE IN EARLY MAY 1969, BEGAN PREPARATION FOR REPAIR OF THE RUNWAY AT VINH AIRFIELD. IT APPEARS THE REPAIR ACTIVITY IS CONTINUING AT A MODERATE RATE WITH NO PRIORITY FOR QUICK REPAIR. A SERVICEABLE RUNWAY AT VINH MAY ENABLE THE NORTH VIETNAMESE TO ESTABLISH AN OPERATIONAL JET FIGHTER BASE CLOSER TO THE DE-MILITARIZED ZONE.
